An Aquatic Plant Lake Plan
for Golden Lake– Waukesha County, WI
November, 2017

Introduction

Golden Lake is an approximate 250 acre lake located principally in the Town of Summit, Waukesha County, Wisconsin. A portion of the lake lies in the far east portion of Jefferson County in the Town of Concord.

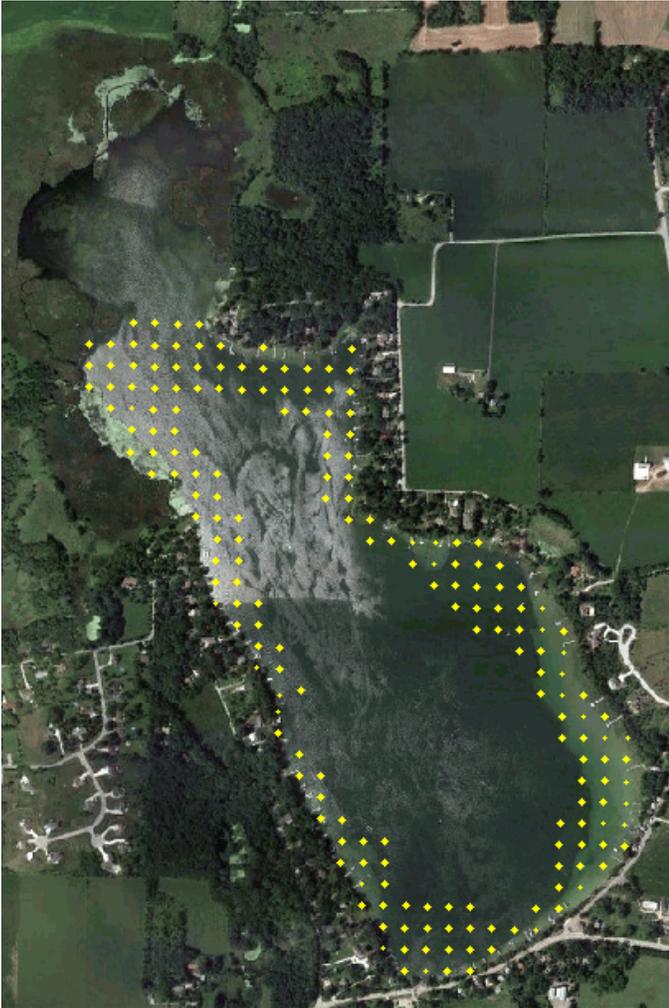
Figure 2

In 2015 and 2016, Partial PI Surveys were conducted that focused on the portion of the lake containing EWM/Hybrid down to a depth of approximately 14 feet. A map for these sites is found in figure 2.

Sampling Points: 201

Sampling Points: 250

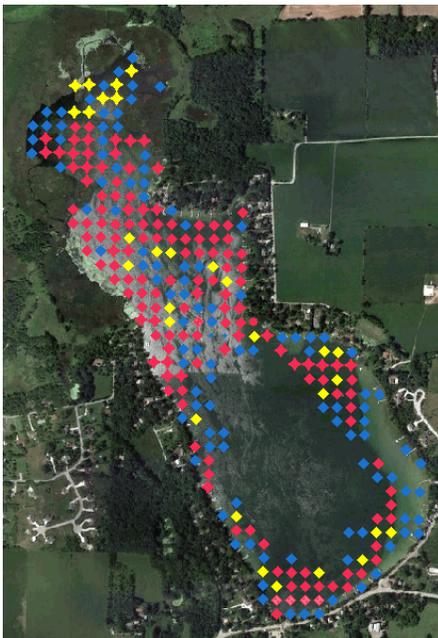
Sites with Aquatic Vegetation (all species)

No. Vegetated Sites: 264

No. of Vegetated Sites: 289

No. of Vegetated Sites: 285

No. of Vegetated Sites: 310

The aquatic plant survey indicated that the lake contains a diverse aquatic plant community. Plants were collected at depths of up to 29 feet during the 2017 survey, and 30-33 ft. during the earlier surveys. Figures #4 and 5 detail the relationship between water depth and the number of sites where aquatic vegetation was found in both Table and Graph forms. Figure 6 provides the location of sites with aquatic vegetation (native or non-native).

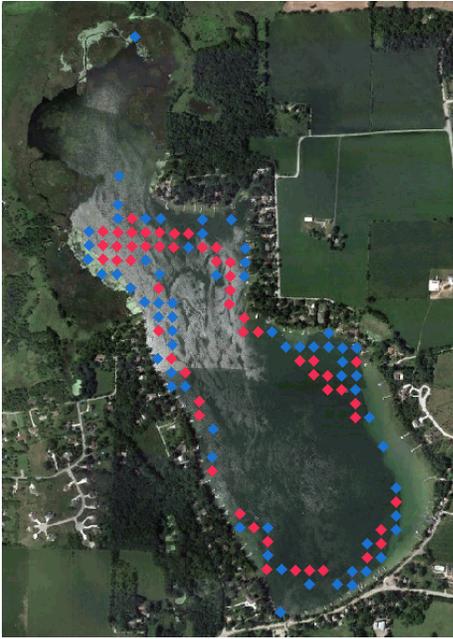
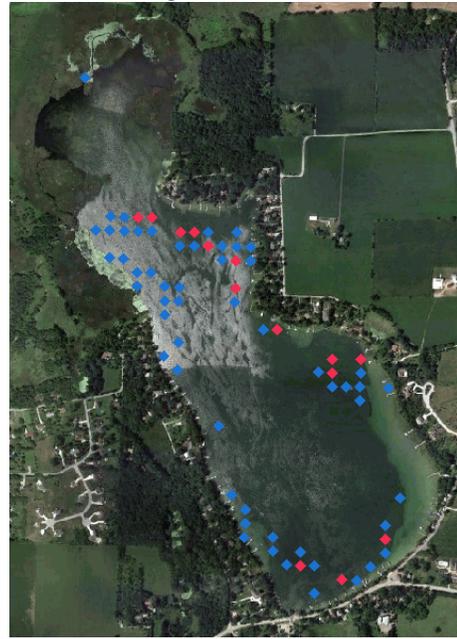
Sites with Eurasian/Hybrid Milfoil

No. Sites: 118

No. Sites: 70

No. Sites: 72

No. Sites: 54 Visual: 6 ◆

The locations where AIS (Eurasian Watermilfoil and/or Curlyleaf Pondweed) were found are shown on Figures #7 and #8. It is important to note that Figure #7 provides Pre and Post Treatment Data showing a significant reduction of Eurasian Watermilfoil following the treatment on June 4, 2013.

It is quite apparent that the initial treatment in May, 2013 had a very positive impact in terms of reducing the amount of EWM in Golden Lake. The number of sites having EWM present in dropped from 118 in May, 2013 to 70 in August, 2013. Herbicidal effects were even observed in the Sensitive Area, which did not receive direct treatment with 2,4-D.

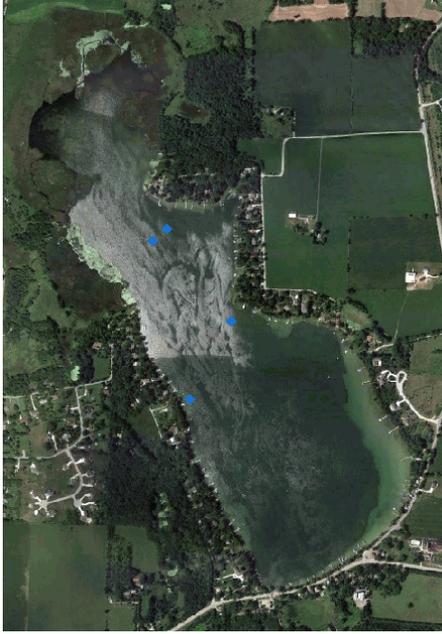
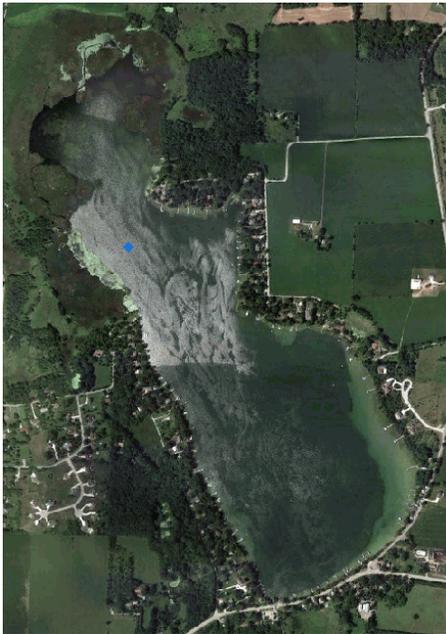
Sites with Curlyleaf Pondweed (*Potamogeton crispus*)

No. Sites: 4

No. Sites: 1

While Curlyleaf Pondweed has been observed in Golden Lake, very little has been detected during the formal PI Surveys due to survey timing. This species typically reaches a maximum biomass in late May/mid June, then dies back after the 4th of July. It may re-develop once again somewhat in late Fall once water temperatures have cooled.

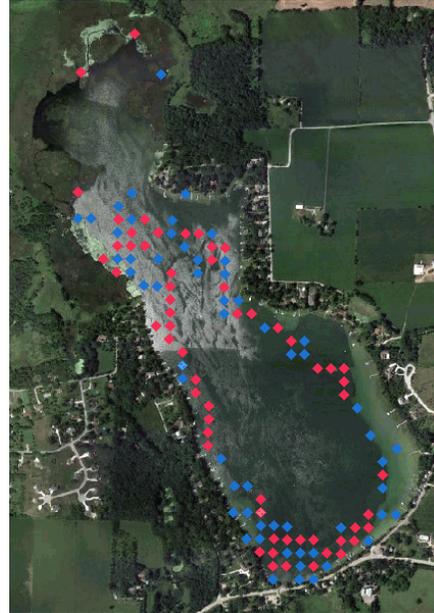
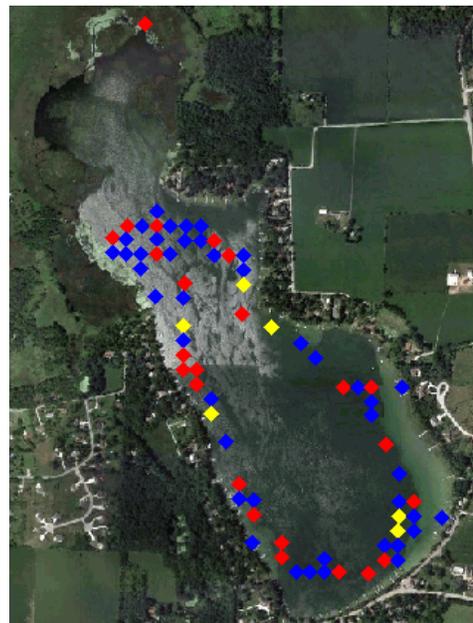
Golden Lake, Waukesha/Jefferson Counties, WI
Sites with Coontail (*Ceratophyllum demersum*)

No. Sites: 64 (Rank #2)

No. Sites: 93 (Rank #3)

No. Sites: 106 (Rank #3)

No. Sites: 73 (Rank #3)

Figures 9-15 detail the location of the Top Seven Ranked Native Plant Species observed in Golden Lake during the 2017 survey. Maps of the distribution and rake fullness for these species during previous surveys are also provided as a comparison.

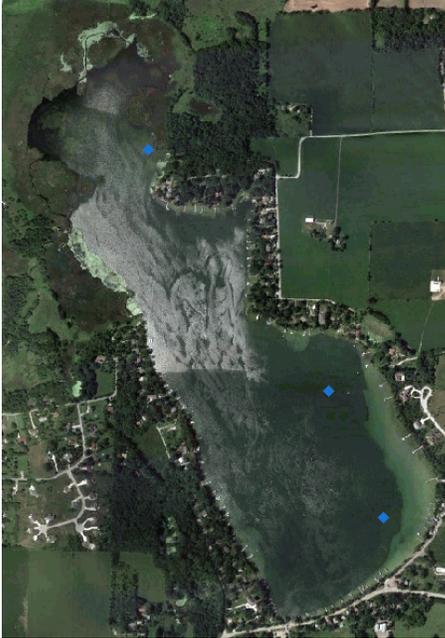
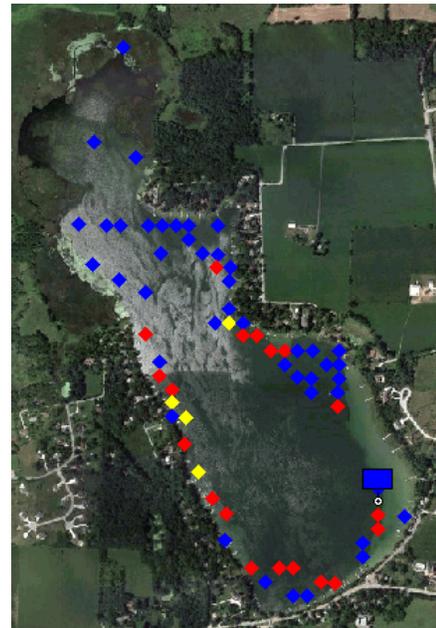
Golden Lake, Waukesha/Jefferson Counties, WI
Sites with Eelgrass (*Vallisneria americana*)

No. Sites: 3 (Rank #20)

No. Sites: 113 (Rank #2)

No. Sites: 107 (Rank #2)

No. Sites: 68 (Rank #4)

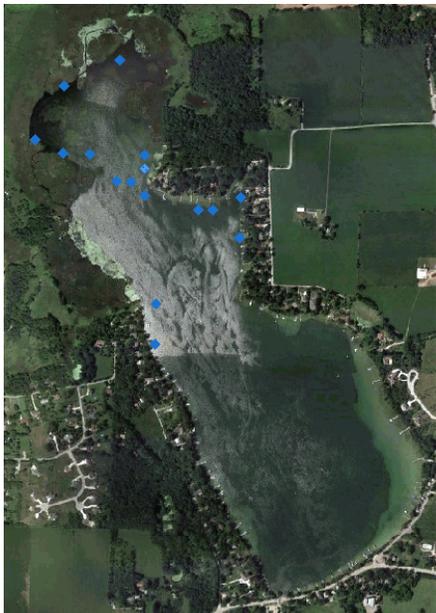
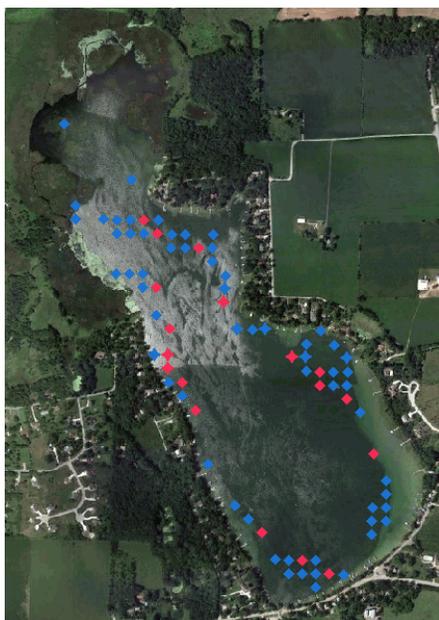
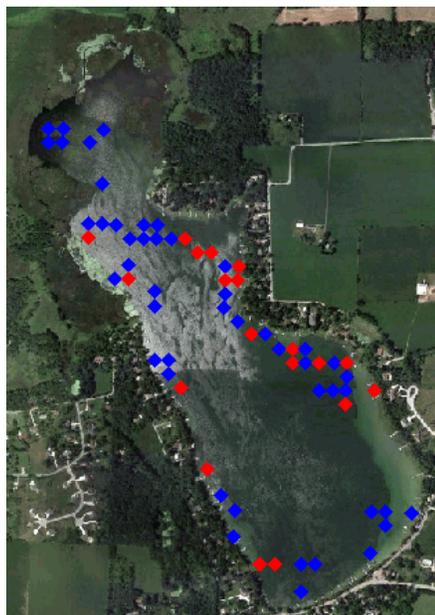
Golden Lake, Waukesha/Jefferson Counties, WI
Sites with Sago Pondweed (*Stuckernia pectinata*)

No. Sites: 16 (Rank #9)

No. Sites: 68 (Rank #5)

No. Sites: 78 (Rank #4)

No. Sites: 66 (Rank #5)

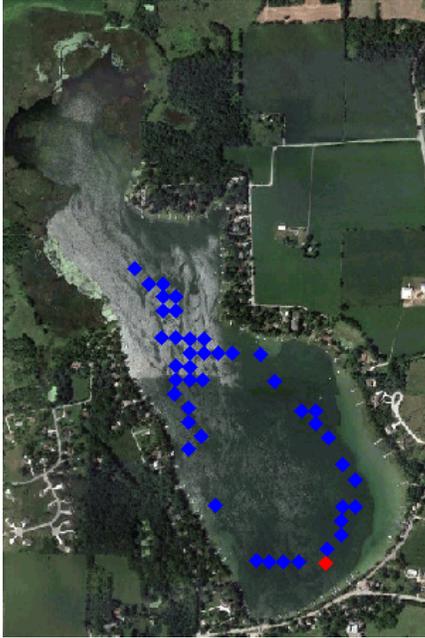
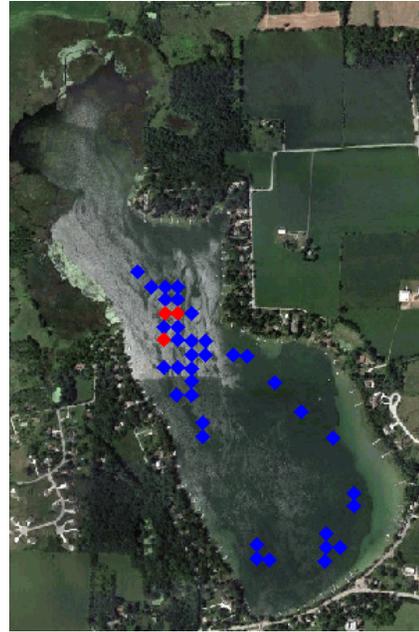
Golden Lake, Waukesha/Jefferson Counties, WI
Sites with *Nitella* (*Nitella*, spp.)

No. Sites: 44 (Rank #4)

No. Sites: 39 (Rank #8)

No. Sites: 41 (Rank #4)

No. Sites: 60 (Rank #6)

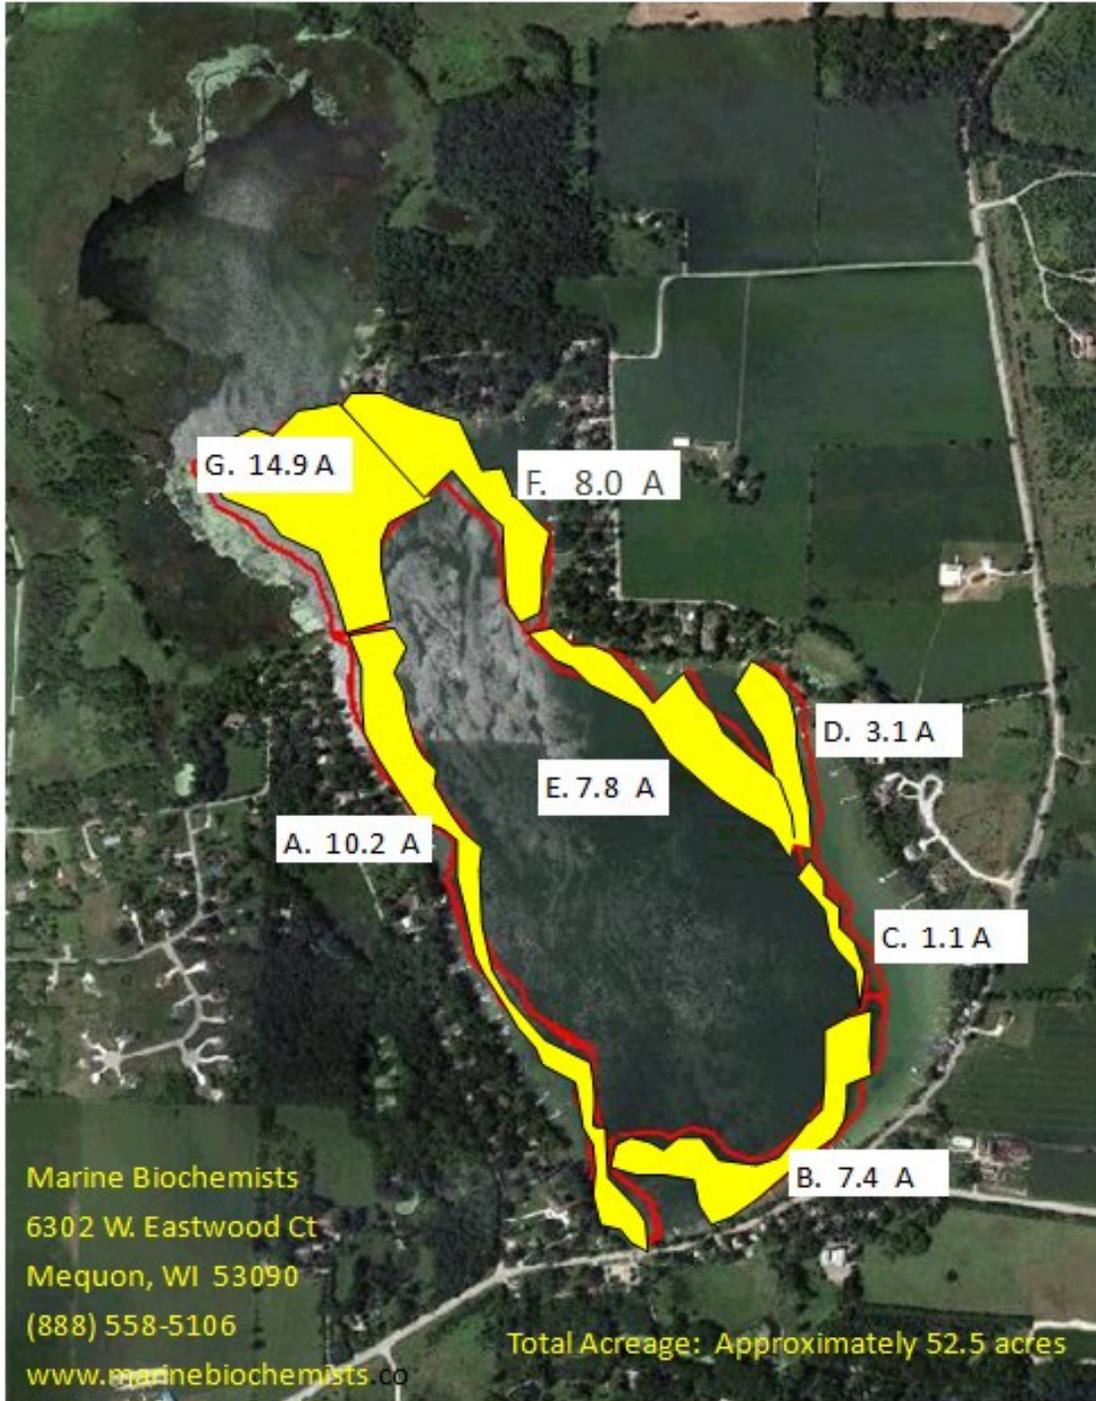
DISTRIBUTION OF MILFOIL, SPP IN GOLDEN LAKE-WAUKESHA COUNTY, WI

OCTOBER, 2012

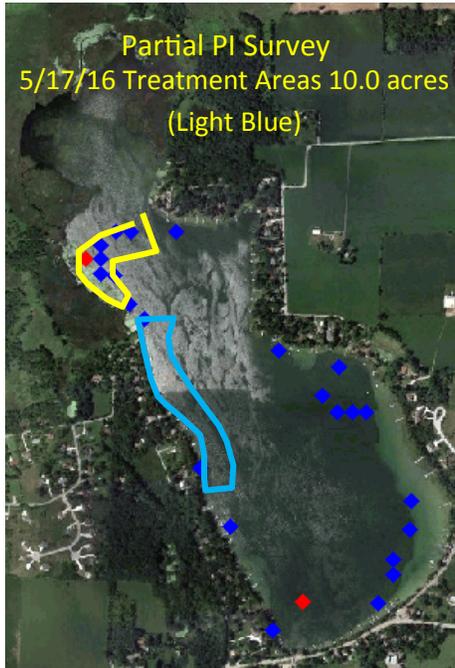
Figure 21

Comparison of EWM Sites Inside/Outside of Sensitive Area in Treatment Areas
 Full PI Surveys (2013/14/17) and Partial PI Surveys (2015/16)

EWM Sites Outside Sensitive Area: 89
 # Inside Sensitive Area Mgmt. Area: 27

EWM Sites Outside Sensitive Area: 53
 # Inside Sensitive Area Mgmt. Area: 17

EWM Sites Outside Sensitive Area: 53
 # Inside Sensitive Area Mgmt. Area: 19

EWM Sites Outside Sensitive Area: 28
 # Inside Sensitive Area Mgmt. Area: 17

EWM Sites Outside Sensitive Area: 17
 # Inside Sensitive Area Mgmt. Area: 8

EWM Sites Outside Sensitive Area: 38
 # Inside Sensitive Area Mgmt. Area: 20

EWM increased slightly in regards to frequency, with 72 sites overall in 2014. This was due to an increase in the number of sites present in the Sensitive Area (19 sites vs. 17). EWM was again reduced in 2015 following the May herbicide treatment. While the number of sites within the Sensitive Area decrease slightly (19 sites to 17), a more marked decrease was found in the areas outside of the Sensitive Area (53 sites to 28). While this can be attributed, in part, to a reduction in the number of sampling points (Partial PI vs. Full), there was a considerable reduction in EWM frequency (and density) within the treatment area along the south shore (see Figure 20, page 26).

Based on the results of the 2017 Survey, the number of points of EWM has increased in the Sensitive Area (Figure 20) and the rake fullness has increased to 2.21 while other parts of the lake are at 1.21 rake fullness. Repetition of DASH for subsequent years harvesting all the EWM present should be considered to determine its impact and effectiveness to maintain and preserve the Sensitive Area’s ecological resources.

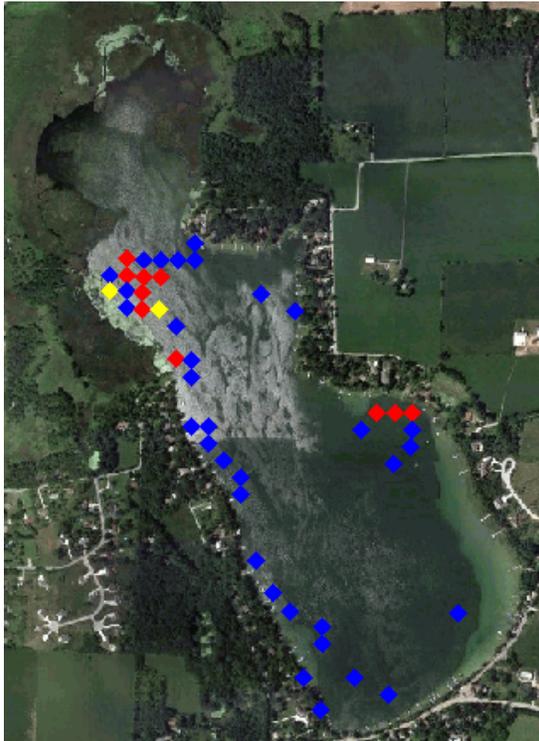
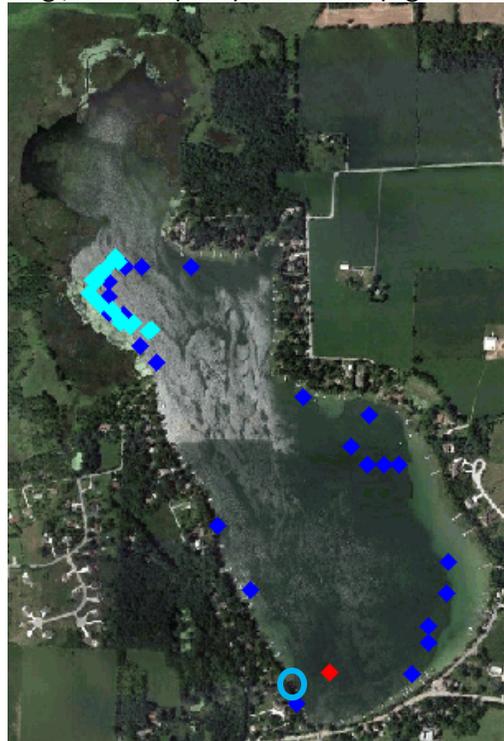
EWM Distribution within Golden Lake and location of Diver Assisted Scuba Harvesting (D.A.S.H.) Treatments

D.A.S.H. conducted on 6-20-2016

Note: Mostly CLP harvested with some EWM

D.A.S.H. conducted on June 20-23, 2017
Note: Harvesting limited to eastern half of Sensitive Area due to limited budget /amount of EWM present.

EWM in shallow areas have been harvested by hand since 2015. Figures 22 and 23 are maps showing the location of EWM present within the harvested areas the Fall prior, and the Fall following the harvesting activities. Finally, a Map summarizing all EWM/Hybrid management activities is found on Figure 24

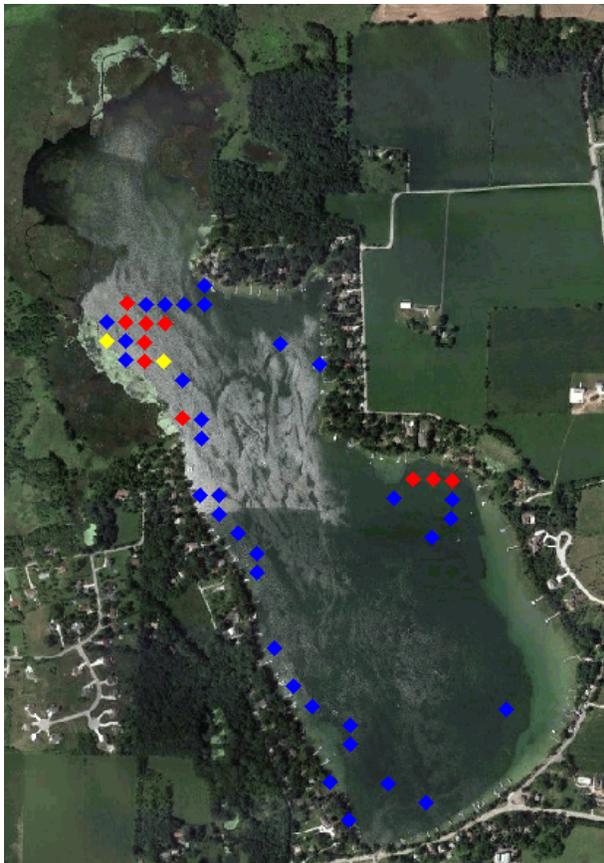
EWM Distribution within Golden Lake and location of Hand Harvesting (Venture) Treatments

Oct., 2015 PI (Post) w Venture-Harvest Superimposed

Aug., 2016 PI (Post) w Venture-Harvest Superimposed

Sept., 2017 PI (Post) w Venture-Harvest Superimposed

In 2017, 239 cubic feet of EWM was harvested. The first hand pulling was conducted in the bay 500 feet off of the east shore at the end of Krueger Road. Two years (2013 and 2015) of herbicide treatment had been applied there. Prior to this harvest, 5 sites with minimal milfoil were present (Fig 23 August, 2016 pre-harvest). Although milfoil was removed here, the site number (5) and density (minimum, Fullness = 1) have remained the same but some of the sites have been relocated. The final 2017 hand pull was done north of the Boat launch due its high boat traffic. No EWM was noted in the area (Sept 2017 PI) after the hand pull as seen in Fig 23.

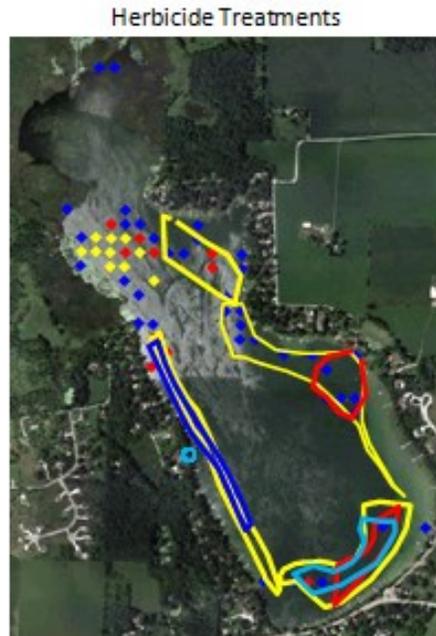
Figure 25

Summary of All Management Activities on Golden Lake 2013-17

Year	Acres
2013	35.6
2015	9.8
2016	10.0
2017	4.5
